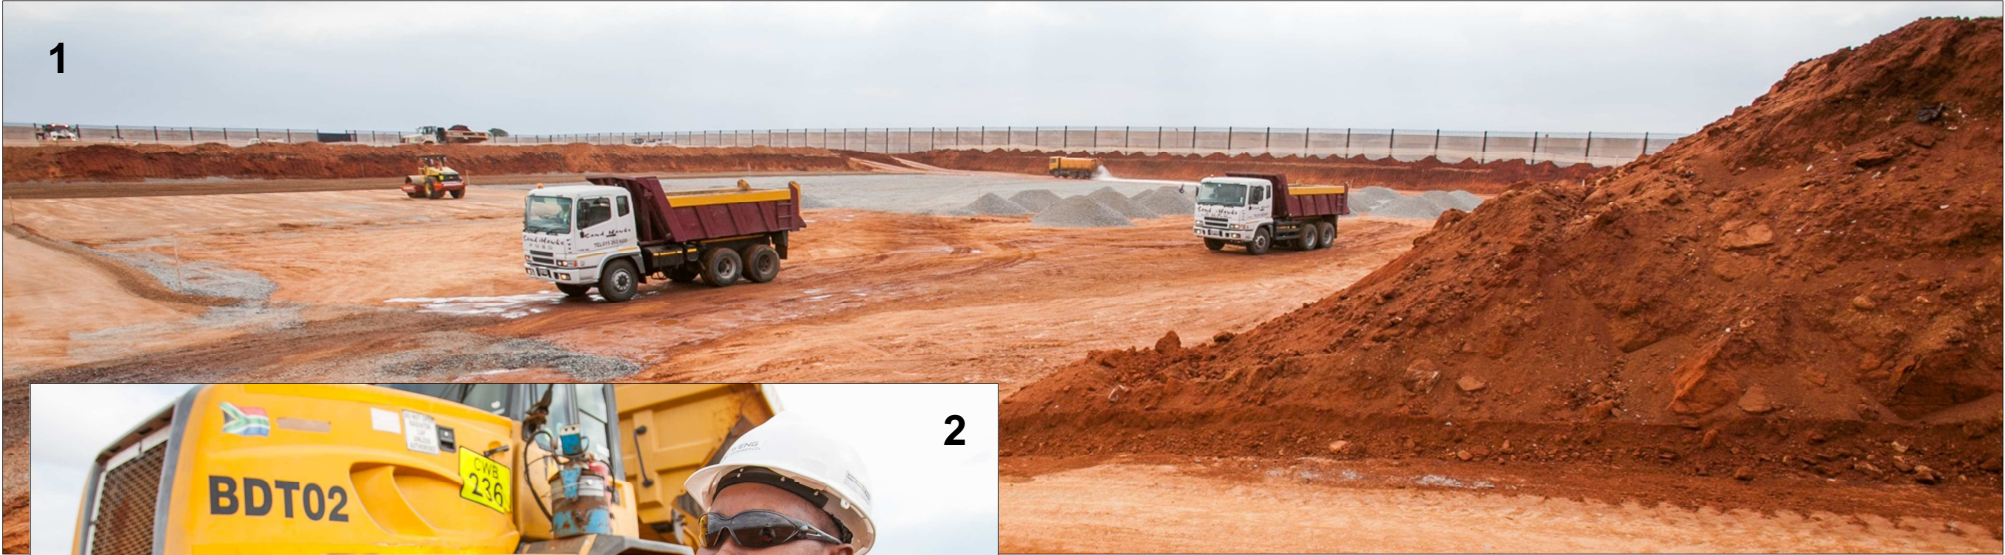
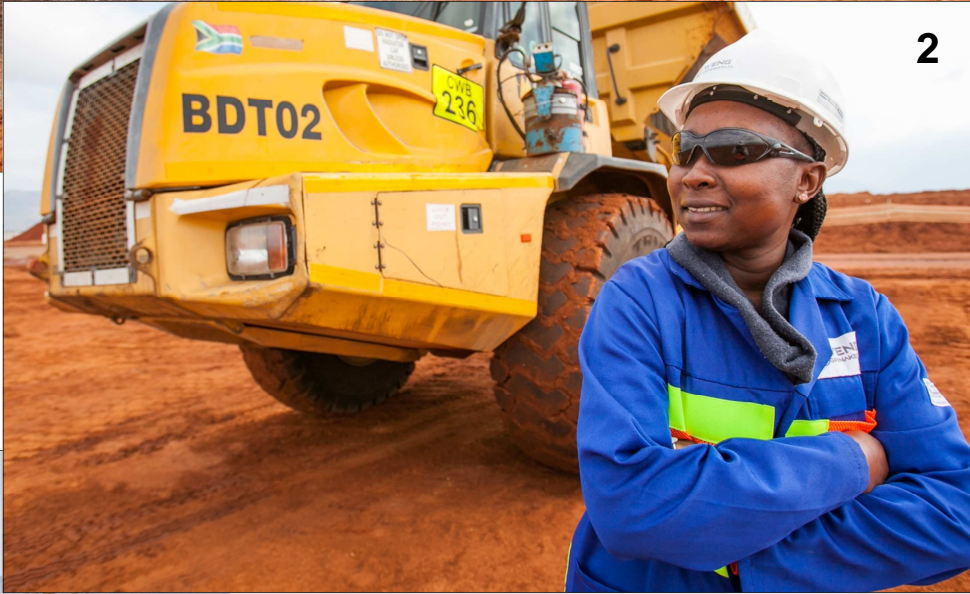
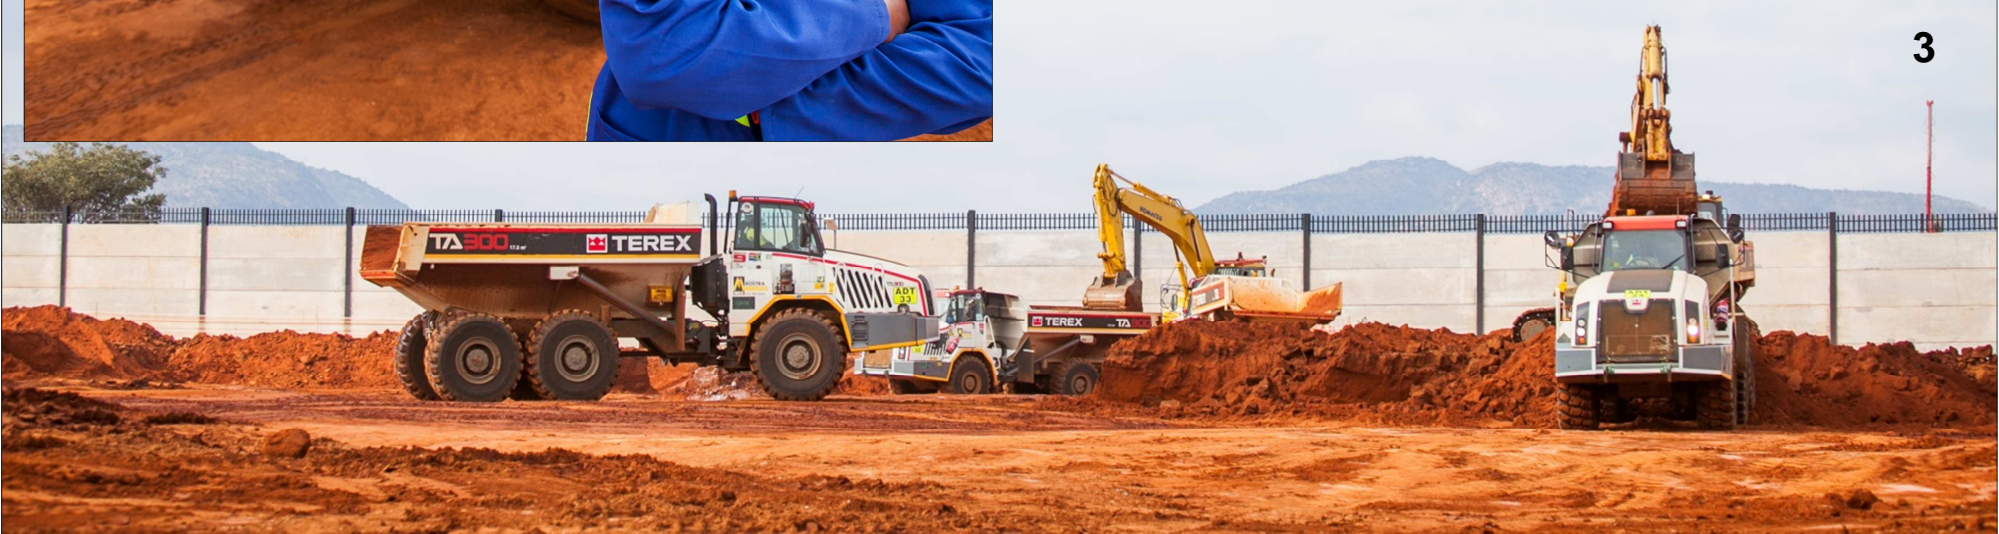
Photos 1 to 3: Earthworks for sinking of Shaft No. 1.
