From TM-2016-756 - SEM/EDS analysis conducted at the CM2 for test #15

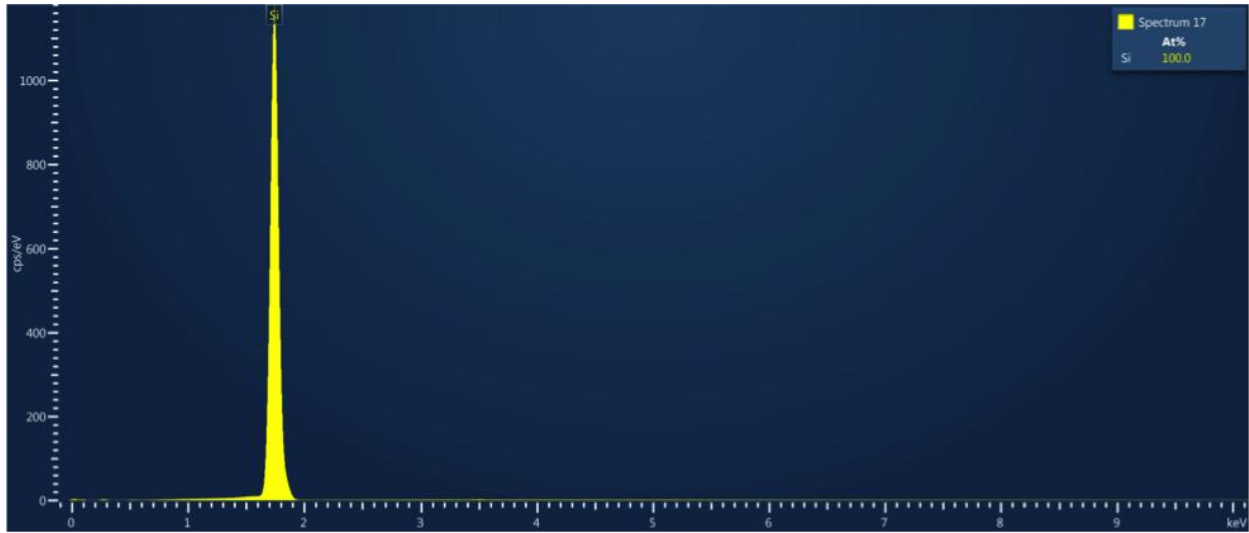
Image 2 – Example of a SEM-EDS Analysis results confirming 100% silicon<sup>6</sup>

<sup>6</sup> Detection limit of the SEM-EDS apparatus is 99.9% purity
