**THE MINA REAL PROPERTY
TECHNICAL REPORT
(SANTA MARIA DEL ORO DISTRICT)
(STATE OF NAYARIT - MEXICO)**

**Rochester Resources Ltd.
Suite 1305 – 1090 West Georgia Street
Vancouver, British Columbia
V6E 3V7 - Canada.**

**VICTOR A. JARAMILLO, M.Sc.(A), P.Geo.
Discover Geological Consultants Inc.**

September 30, 2008

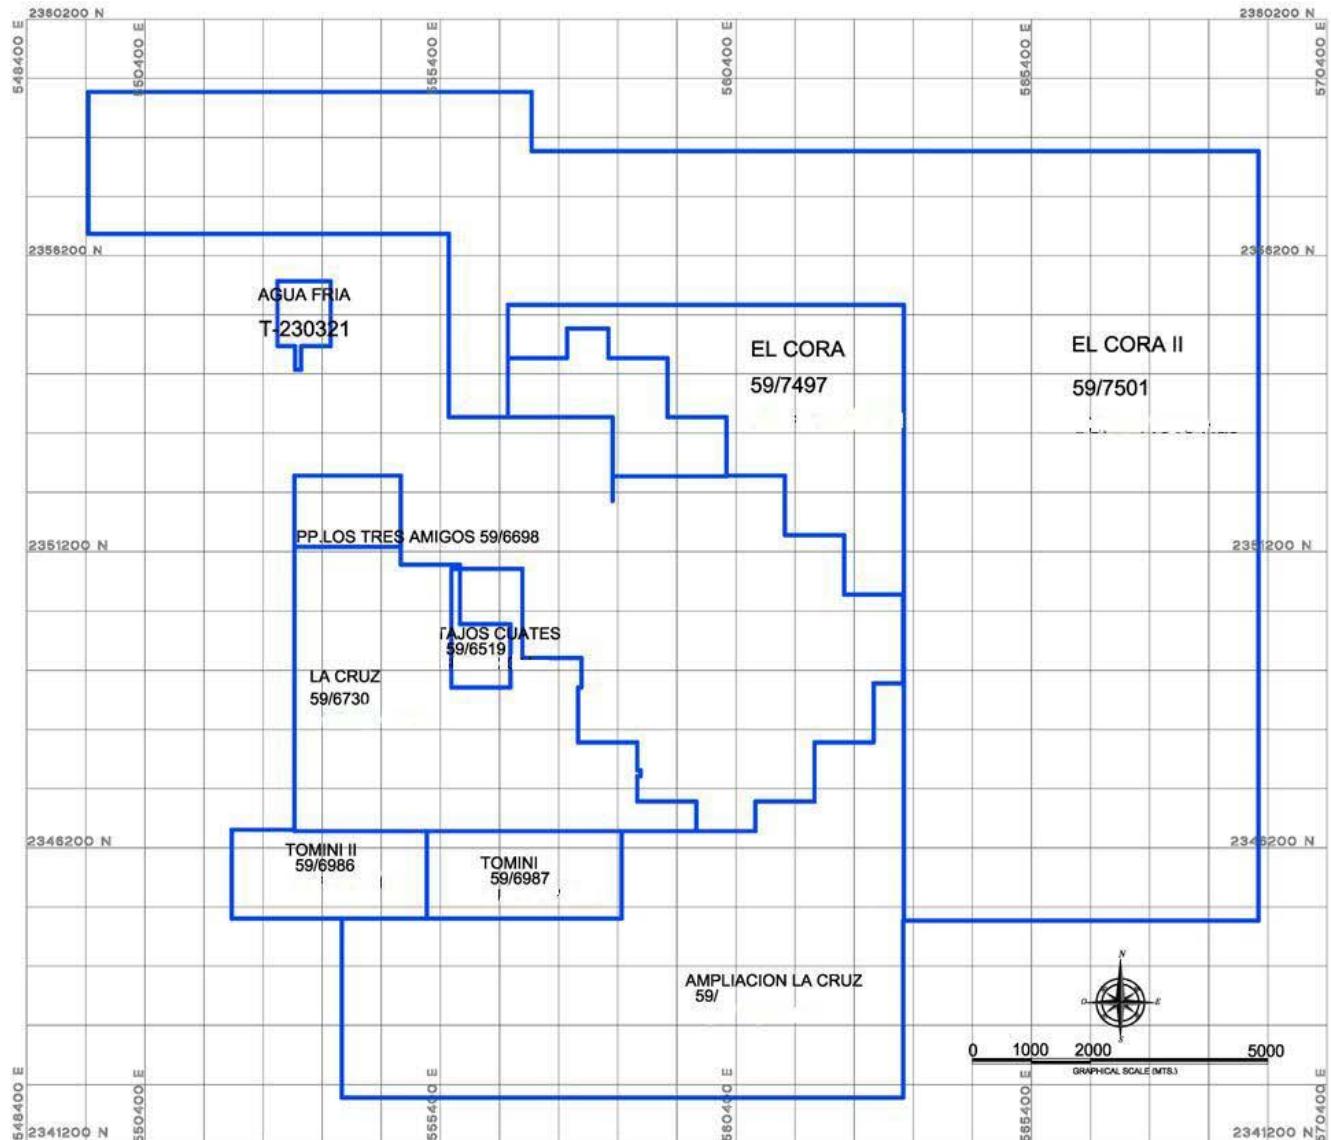
Figure 2: Mina Real Property Claim Map (scale bar in meters)

The mining concessions lie within the INEGI topographic sheets F13 D32 (Santa Maria del Oro) and F13 D42 (Ixtlan del Rio) at 1:50,000 scale each. A property claim map is shown in Figure 2. Table 1 is a list of concessions and claims owned by Mina Real Mexico S.A. DE C.V.

During February 2008 Rochester staked additional prospective ground (13,164 hectares) between the Mina Real Property and the Santa Fe Property. The new claims comprised the “El Cora claim” (1,527 hectares) and the “El Cora II” claim (11,596 hectares). See Figure 2.

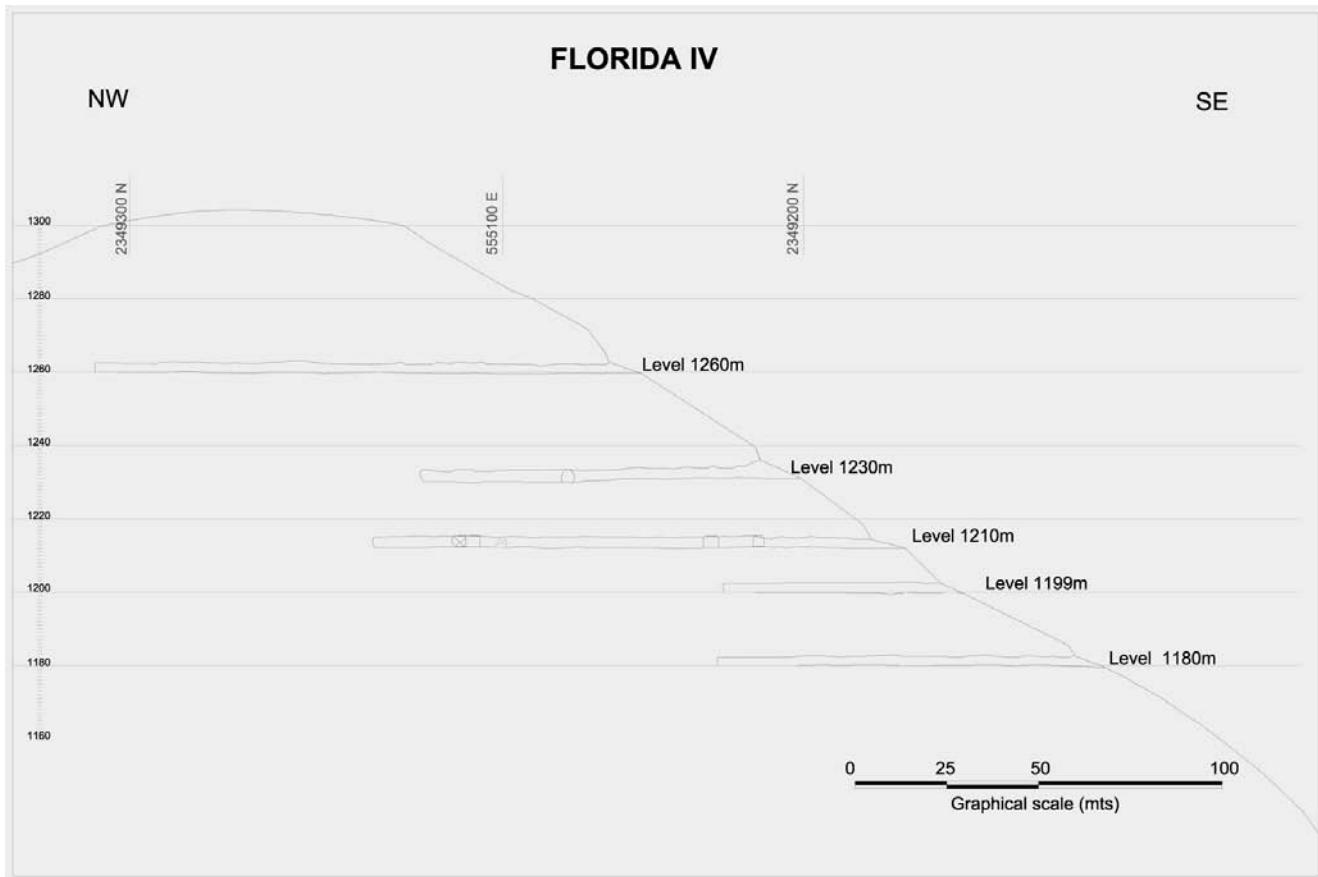
FIGURE 3: Longitudinal section of Florida-4 Vein showing exploration drifts along 5 different levels. View looking NE.

Between July and August 2008 approximately 6.3 kilometres of roads were completed in order to access the Florida-NW area, particularly the Florida-4 Vein. Drifting along the Florida-4 Vein began on levels 1180, 1199, 1210, 1230 and 1260. See Figure 3 below.

Between July and August 2008 approximately 6.3 kilometres of roads were completed in order to access the Florida-NW area, particularly the Florida-4 Vein. Drifting along the Florida-4 Vein began on levels 1180, 1199, 1210, 1230 and 1260. See Figure 3.

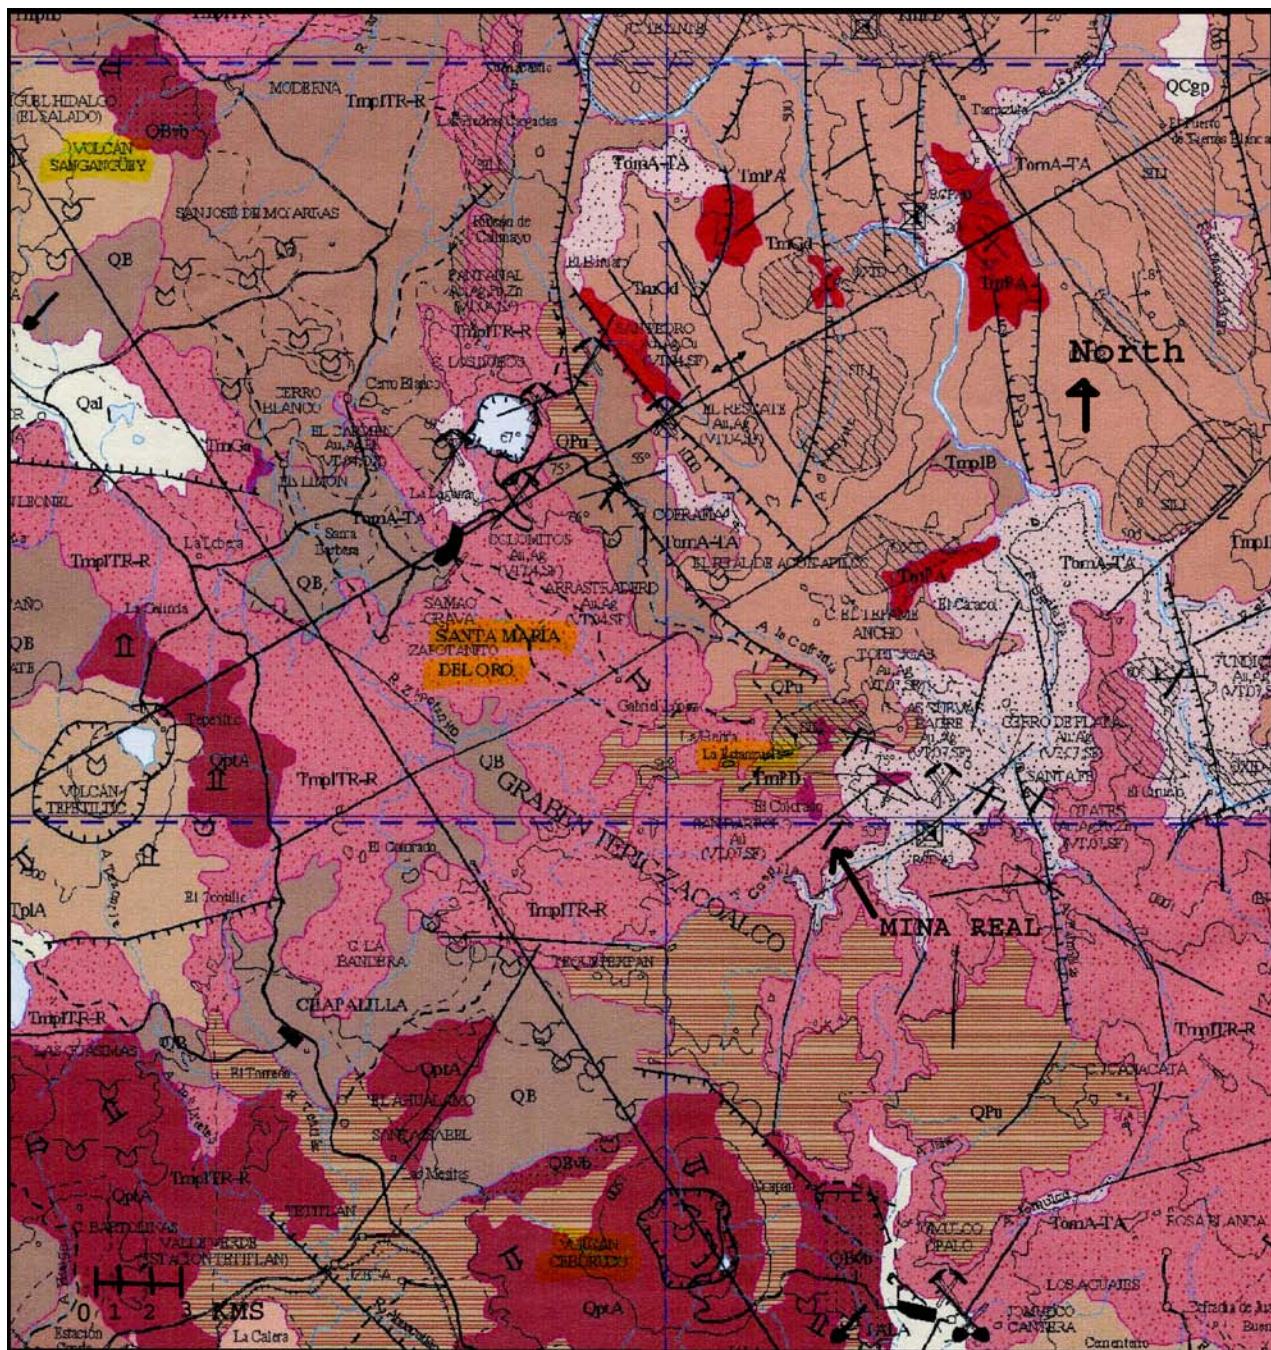
Figure 4 : Regional Geological Map (Source: Mexican Geological Service, Tepic F13-8, Nayarit and Jalisco, 1998.)

The structural geology of the area comprises normal faults with NNW-SSE orientations with subsided blocks to the east and west, which form deep canyons and steep walls. The main regional lineaments are oriented NW-SE, secondary fracturing and faulting have an orientation NW-SE and NE-SW and the main regional structure is the Tepic-Zacoalco Graben (See Figure 4).

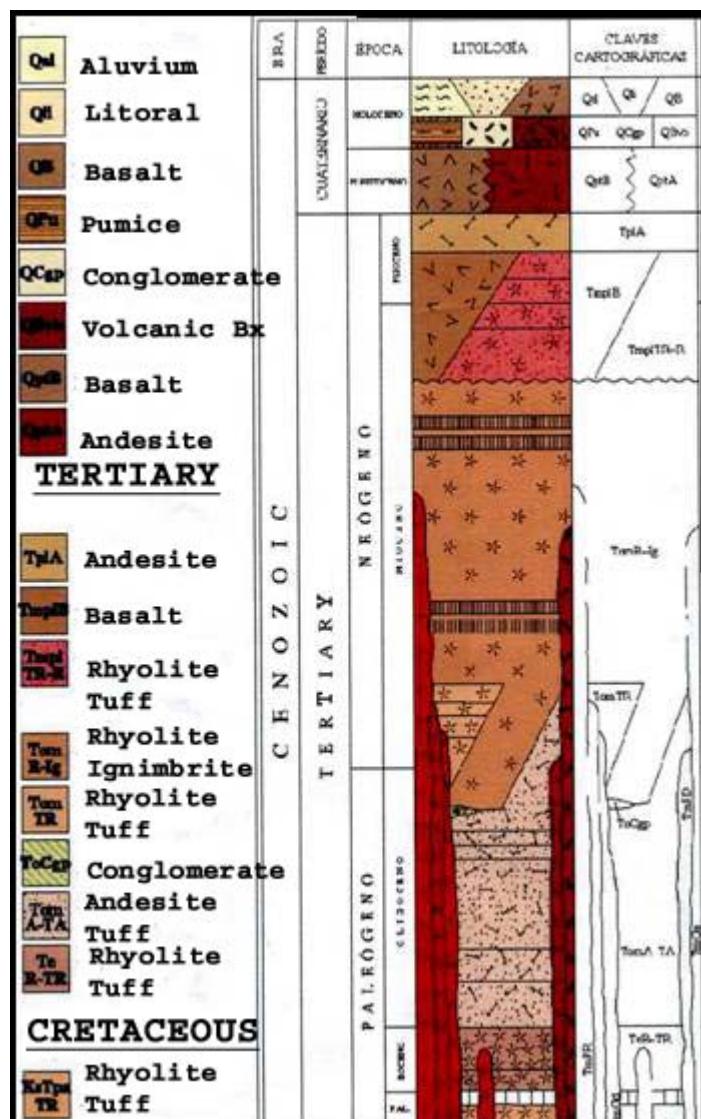
Figure 5 : Regional Stratigraphy (Source: Mexican Geological Service, Tepic F13-8, Nayarit and Jalisco, 1998.)

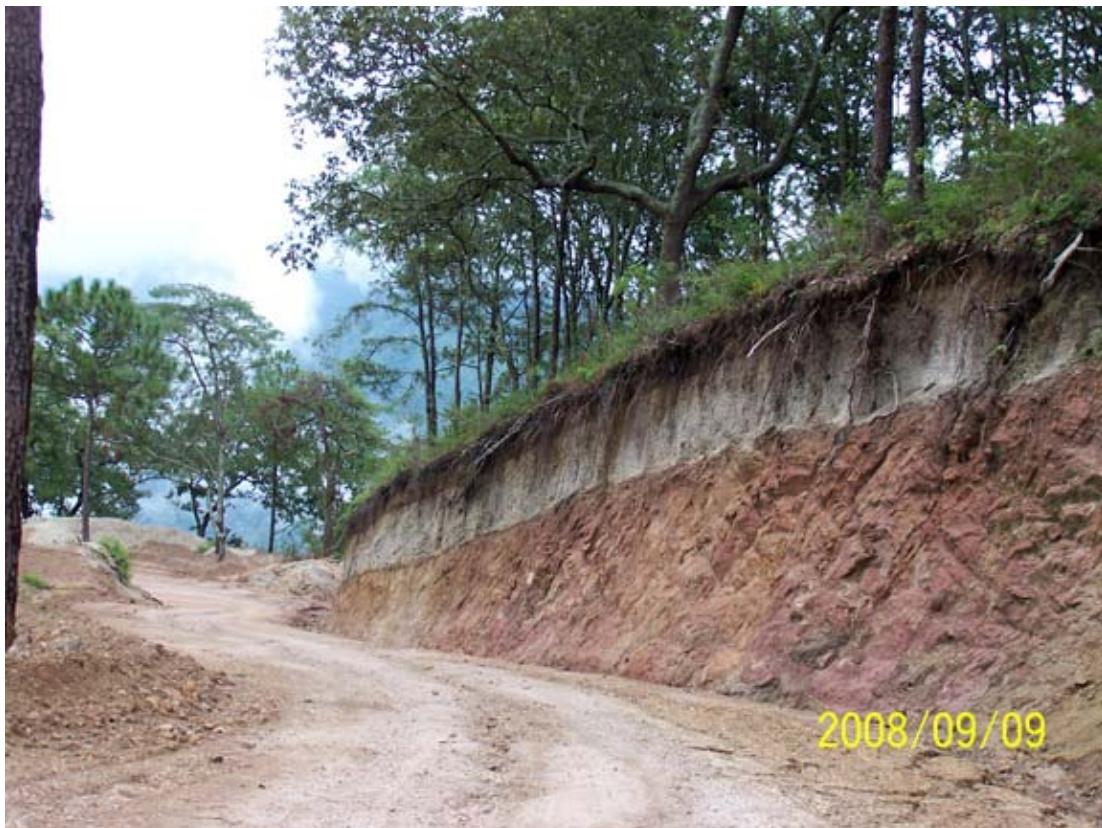
Plate 2: Pumice cover (white layer) along road near Florida-4 Vein

To the north and northwest of the mine area, most of the surface is covered by a layer (0.50 up to 2.0m thick) of pumice volcanic pyroclastics (See Plate 2). This material is very friable and of low density. It masks any vein outcrop and on top has growth of shrubs and pine trees. The pumice dates back to the year 1870 when the Ceboruco Volcano last erupted. Most outcrops near the mine are of dacite ignimbrites and andesite flows.

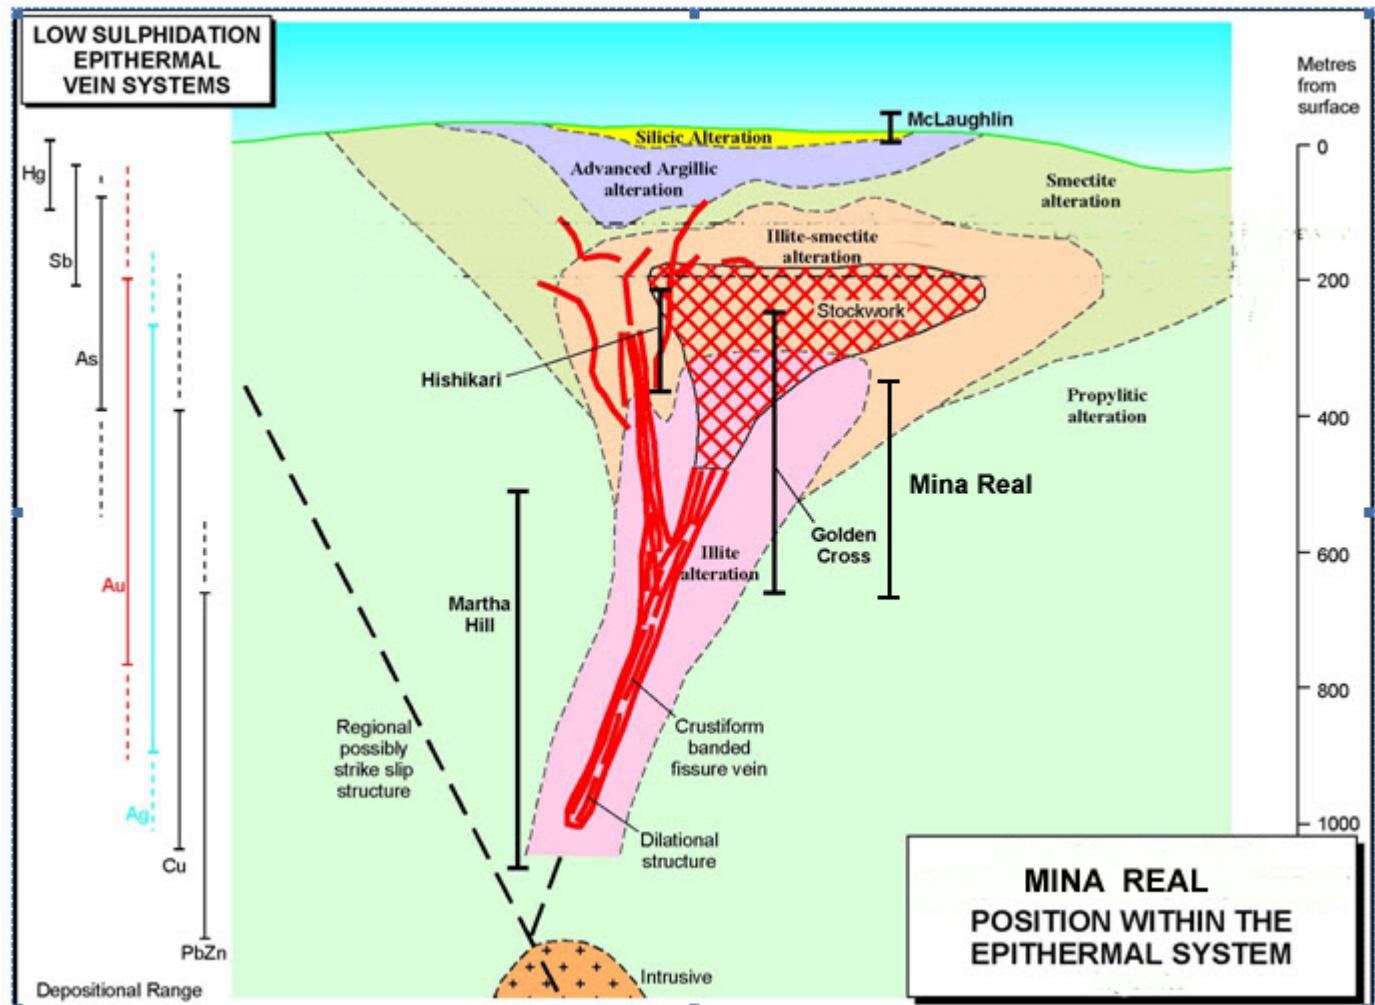
FIGURE 6: Low sulphidation epithermal vein system showing tentative location of the veins at the Mina Real Property. (Modified after Poliquin, 2005)

Figure 6 below illustrates classic low sulphidation epithermal vein systems and indicates a tentative location of the mineralized veins at the Mina Real Property.

To date over 20 quartz veins have been identified (See Figure 6) at Mina Real. The Florida-1, 2 and 3 veins have been the main source of mineralization for the mine mill feed within the last two years. The Tajos Cuates vein is being explored and developed underground.

Recently a vein area called the Florida NW zone, north of the Florida-1, 2 and 3 veins, has been identified. Within this new area a total of 13 quartz veins have been recognized. It has similar mineralogical characteristics as the Florida 3 vein system currently being mined at the Mina Real Property (See Figure 6).

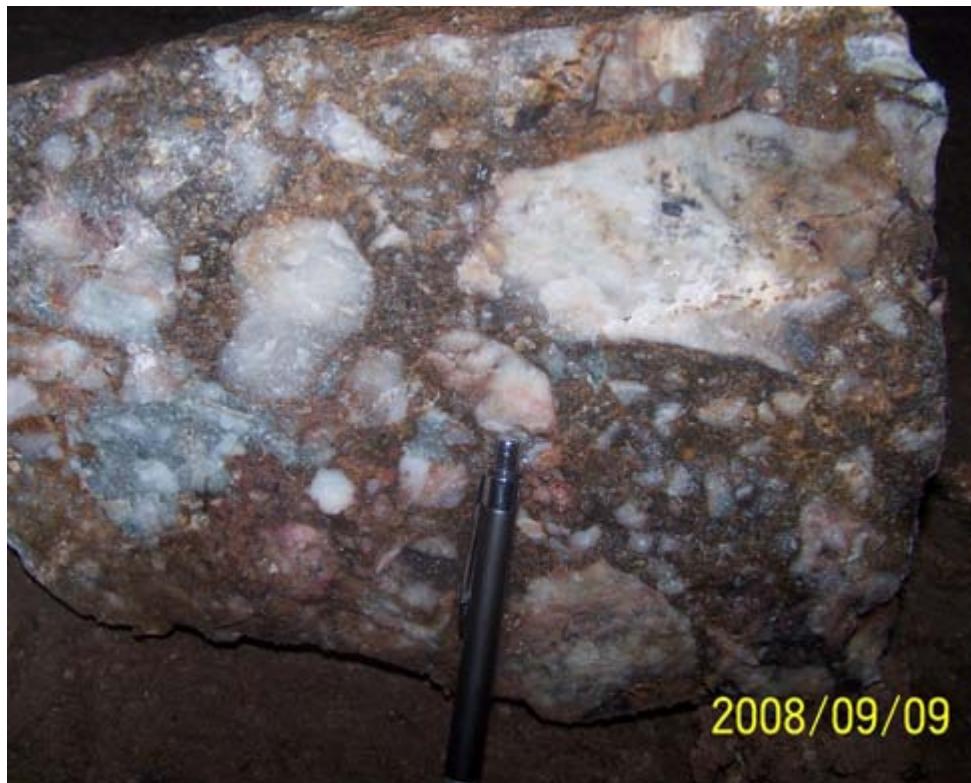
Plate 3: Hand specimen from Florida-4 Vein (level 1210m). It is a hydrothermal breccia which cuts through the main vein.

The Florida-4 quartz vein is parallel and approximately 450 metres west from the Florida 3 vein system. Results collected to date are similar to those observed at the Florida 3 vein at similar elevations (Table 3). The author has observed along sections in the Florida-4 vein drift (level 1210m) hydrothermal breccias of irregular shape. These breccias are mainly composed of sub angular to angular quartz fragments (1 to 15 cm long) in a dark brown silica matrix composed of < 1cm long quartz fragments. The author believes the breccia is a later mineralizing event emplaced after the quartz veining (See Plate 3).

The author has observed along sections in the Florida-4 vein drift (level 1210m) hydrothermal breccias of irregular shape. These breccias are mainly composed of sub angular to angular quartz fragments (1 to 15 cm long) in a dark brown silica matrix composed of < 1cm long quartz fragments. The author believes the breccia is a later mineralizing event emplaced after the quartz veining (See Plate 3).

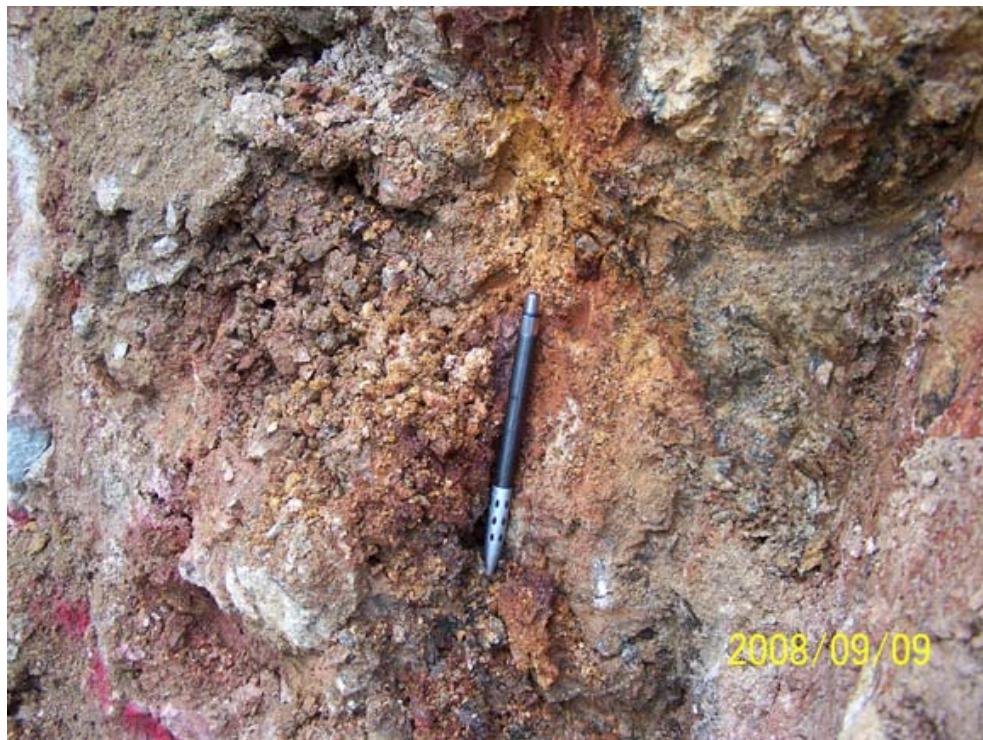
Plate 4: The La Vibora Area showing strongly fractured and weathered wall rock with iron oxides.

The writer at the La Vibora Vein area observed that the host rocks are strongly fractured and contain hematite and limonite. Fine coarse gold particles were observed (after crushing, grinding and washing) from a grab sample taken from weathered wall rock containing strong iron oxides (See Plate 4 below).

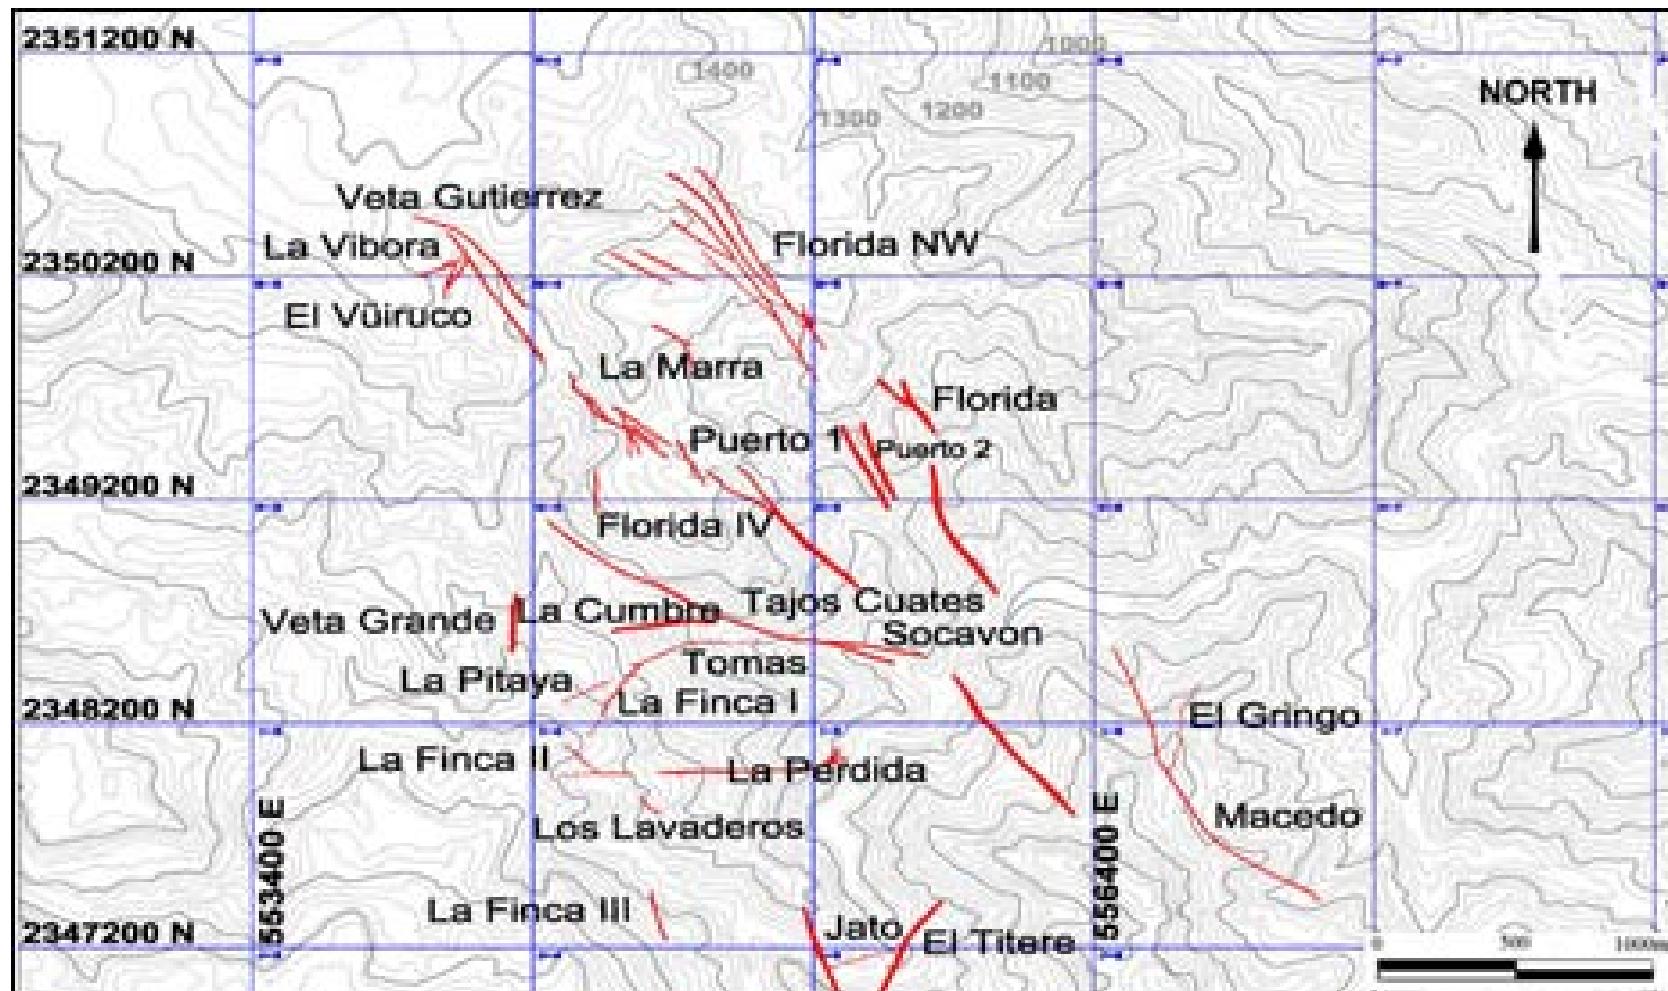
FIGURE 7: Map of veins in the Mina Real Property (veins are shown as red lineaments).

A Vein system called Tajos Cuates south of the Florida Veins (Figure 7), was also visited and sampled by the writer during 2005. One of the samples taken of the vein had a true width of 1.70 meters and was composed of fractured quartz and concentrations of limonite and manganese oxides. It appeared to be a large zone of secondary enrichment. It returned 2.77 g/t gold and 1,330 g/t silver (Jaramillo, V., 2006).

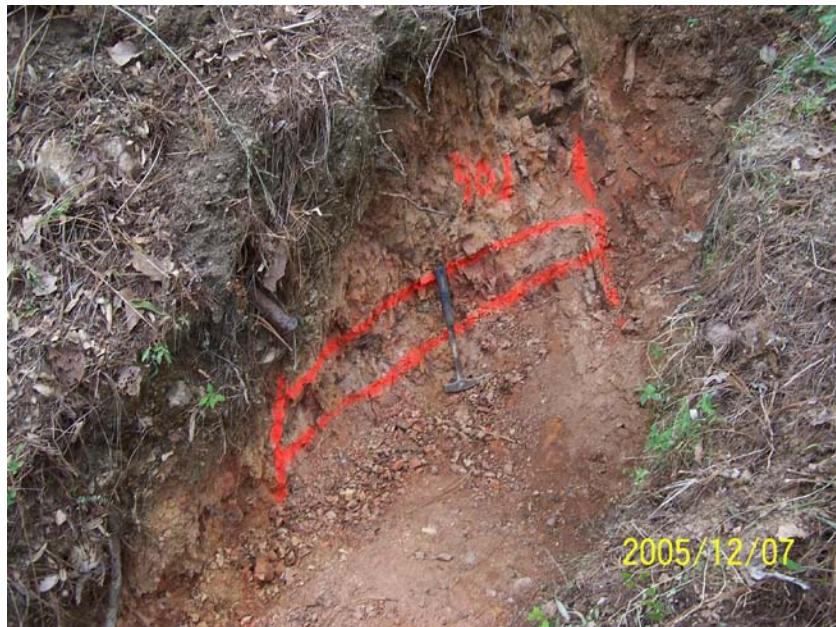
Plate 5: Quartz Vein in trench approximately 1 km NW of Florida-3 vein area. The vein width was 1.10 meters and returned 1.20 g/t gold and 123 g/t silver (Jaramillo, V., 2006)

A quartz vein was found in an old trench (Plate 5). The vein had a width of 1.10 meters, strikes 330 degrees and has a dip of 62 degrees SW. A chip sample No. 387401 was taken and gave 1.20 g/t gold and 123 g/t silver. The vein is found approximately 1 kilometre NW of the Mine area. A GPS reading for the vein gave: 555,086-E , 2,350,293-N at an elevation of 1,420 meters.

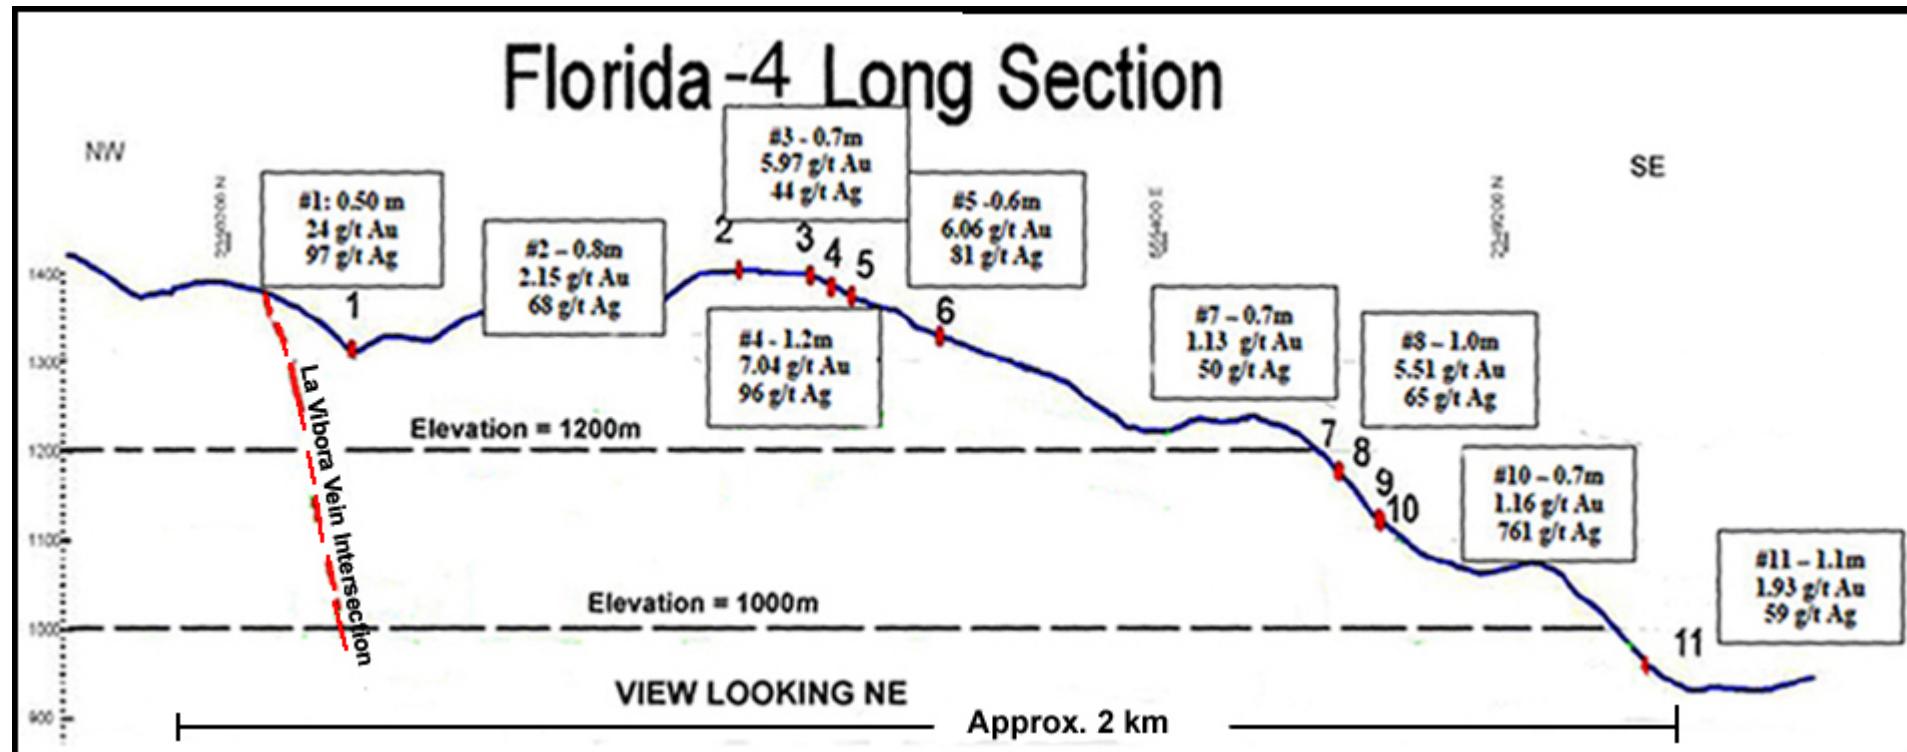
FIGURE 8: Schematic long section of the Florida-4 Vein with approximate trench locations (11 trenches)

The trenches are located at different elevations ranging from 1000 meters above sea level to 1400 meters above sea level (figure 8). The vein system has a well defined quartz structure with widths on surface ranging from 0.3 metres to 1.5 metres. Sampling was completed at all 11 trench locations and 9 locations reported significant gold and silver values (Table 3).

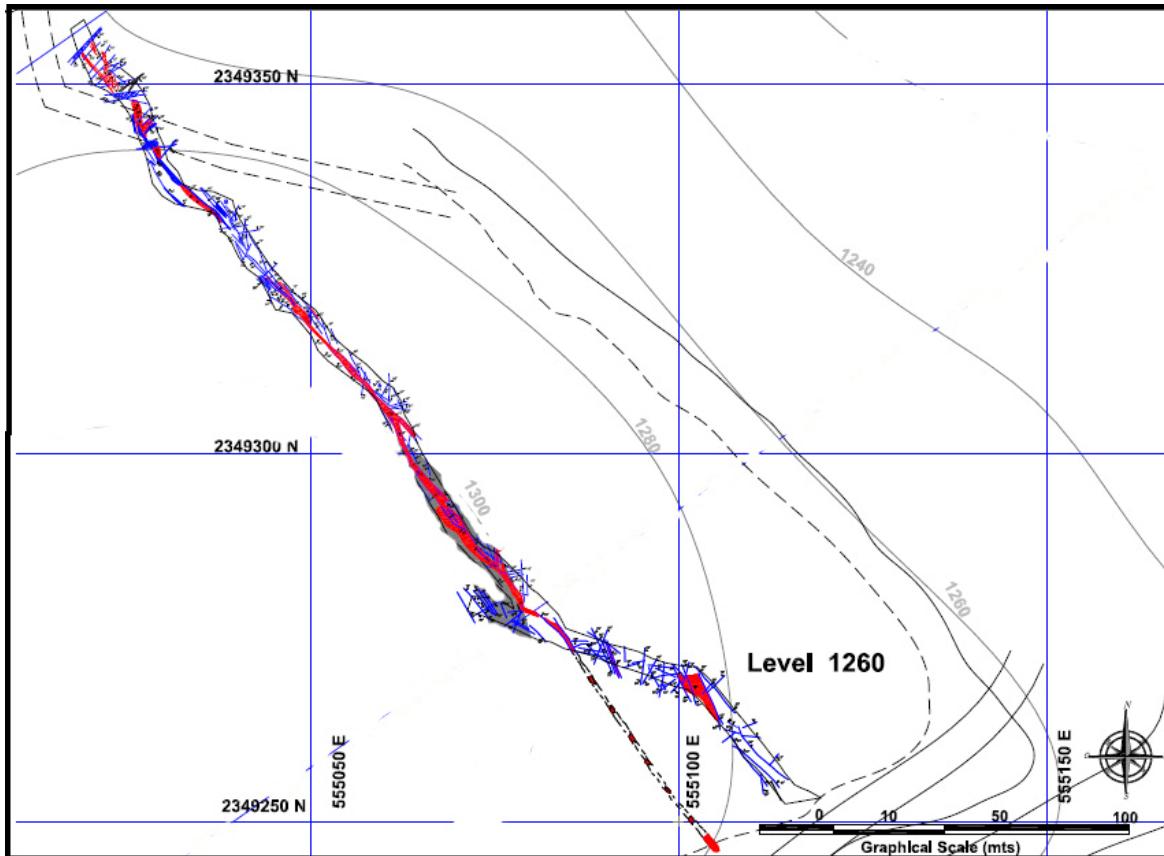
FIGURE 9: Underground geology map of Florida-4 vein (Level 1260m).
Red color = quartz vein ; Blue color = fault zones

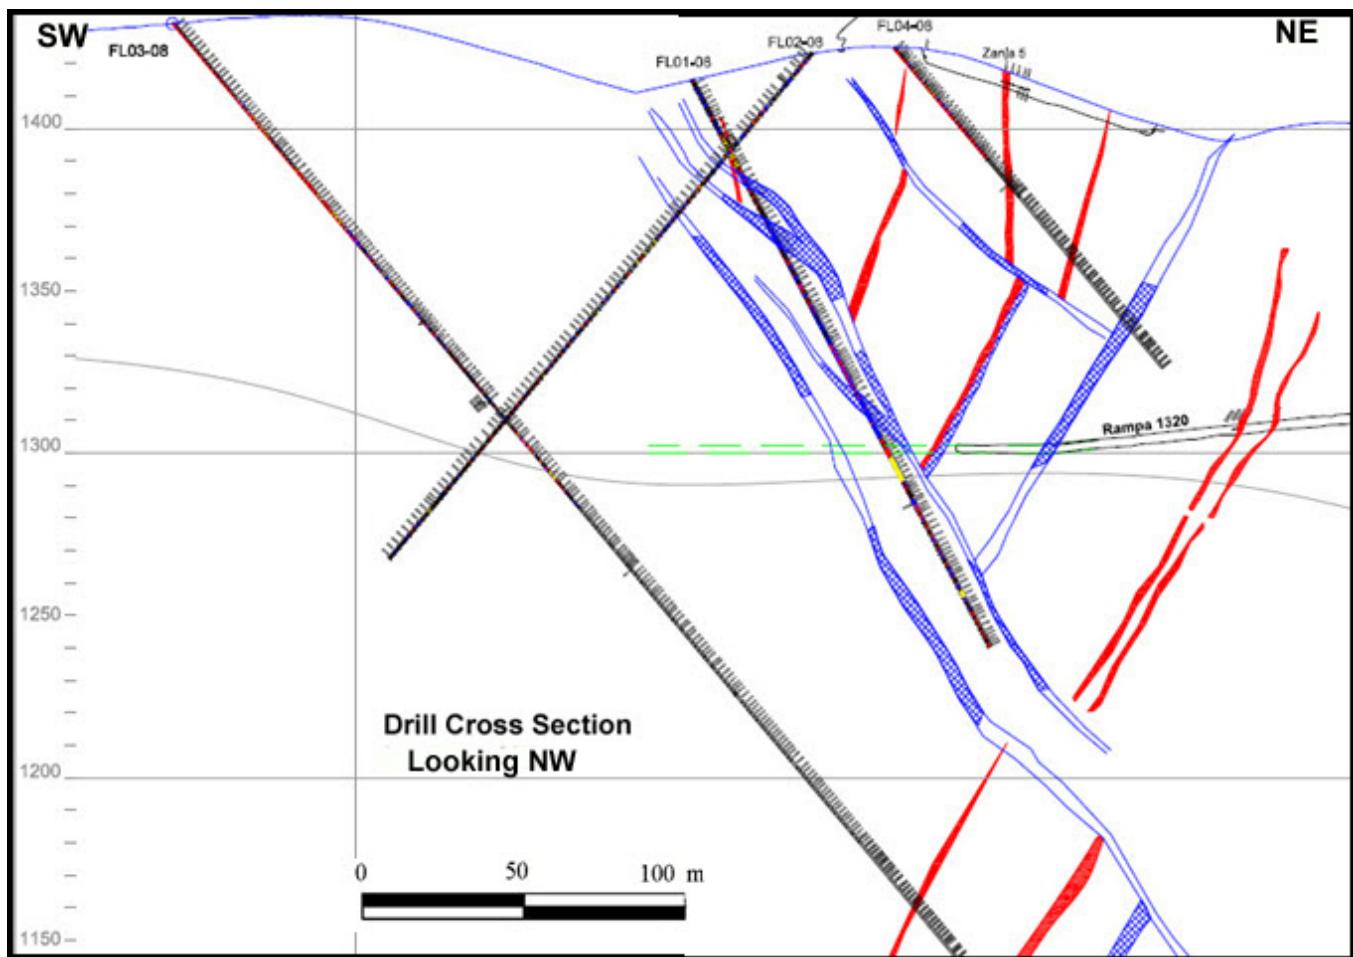
FIGURE 10: Florida-4 Vein Drill Hole Cross Section

In early 2003 Luismin drilled two core holes in order to explore the continuity of the Florida Veins to the NW and at depth. Drill hole DDH F1-03 was to test the vein continuity to the NW, but it did not reach the required depth due to technical difficulties and poor recoveries. Subsequent investigation revealed that this drill hole required at least another 50 meters of drilling as the veins have been faulted further west. See Figure 10.

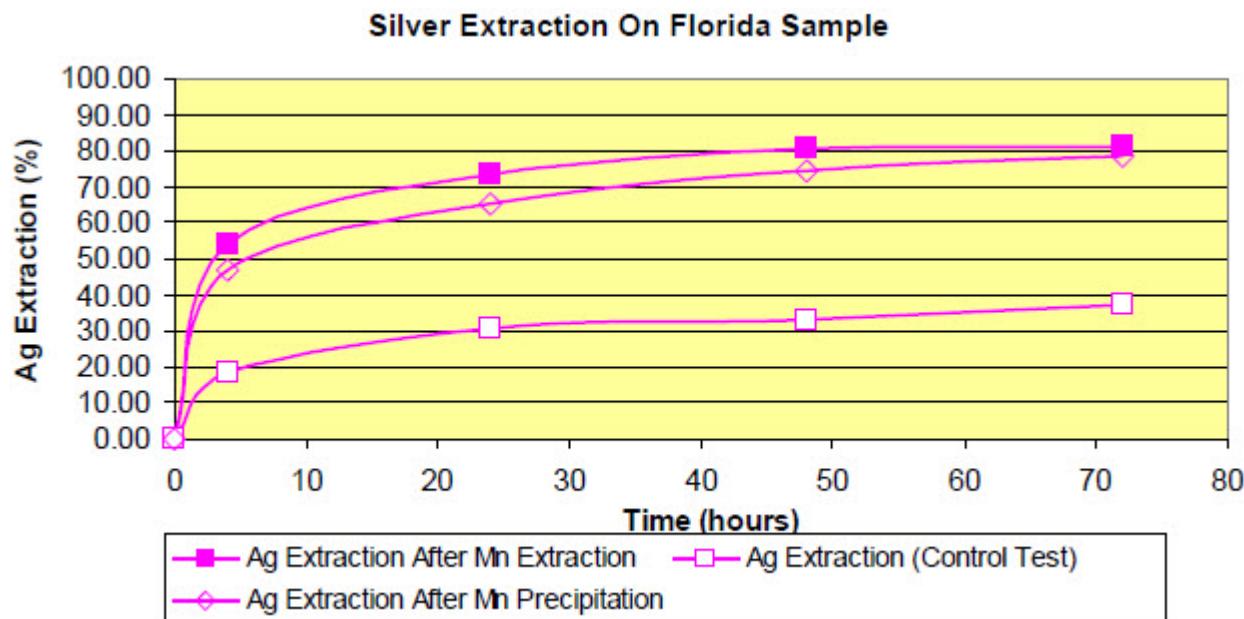
FIGURE 12: Silver extraction on Florida sample

The metallurgical data developed on the Florida-3 sample are summarized in Table 9 and in Figures 12 and 13 below.

- Gold Extraction ranged from 94.59 percent to 95.57 percent. The highest gold extraction was observed on the control test.
- Silver Extraction ranged from 37.49 percent to 81.047 percent. The highest silver extraction of 81.04 percent was observed on the cyanidation test conducted after manganese dissolution using sulphurous acid followed by manganese removal by solids/liquid separation.

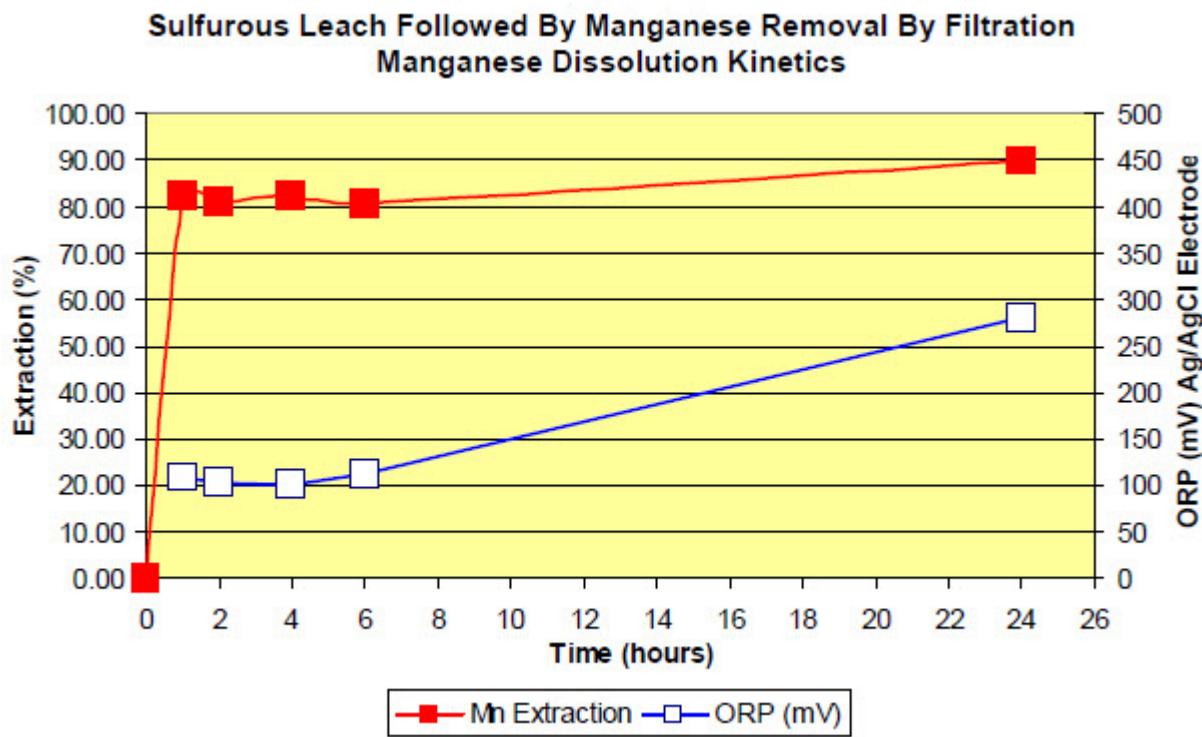
FIGURE 13: Sulphurous leach followed by manganese removal by filtration.

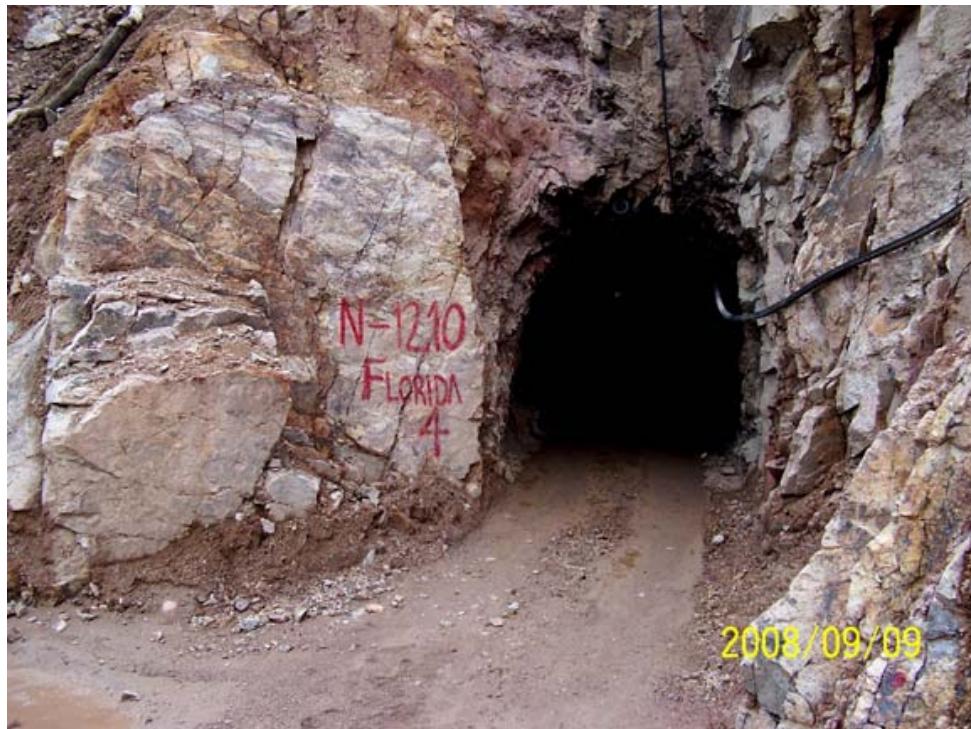
The Florida-4 Vein Adit (level 1210m)

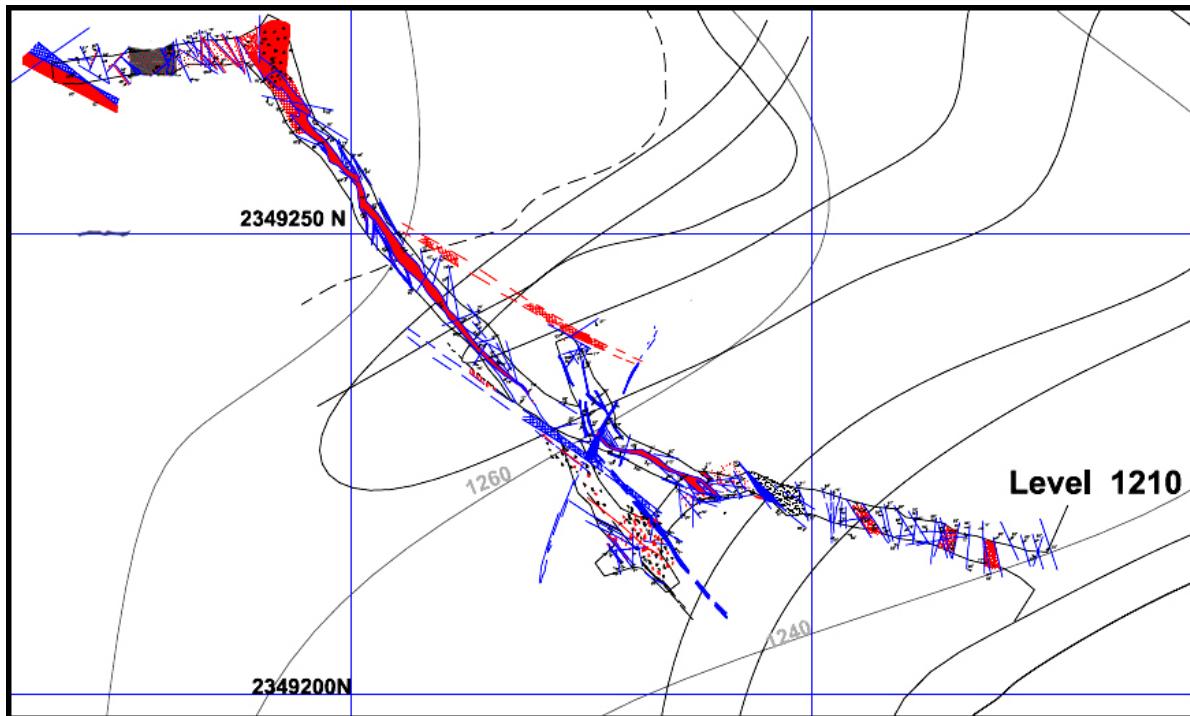
Underground geology map of Florida-4 vein (Level 1210m)

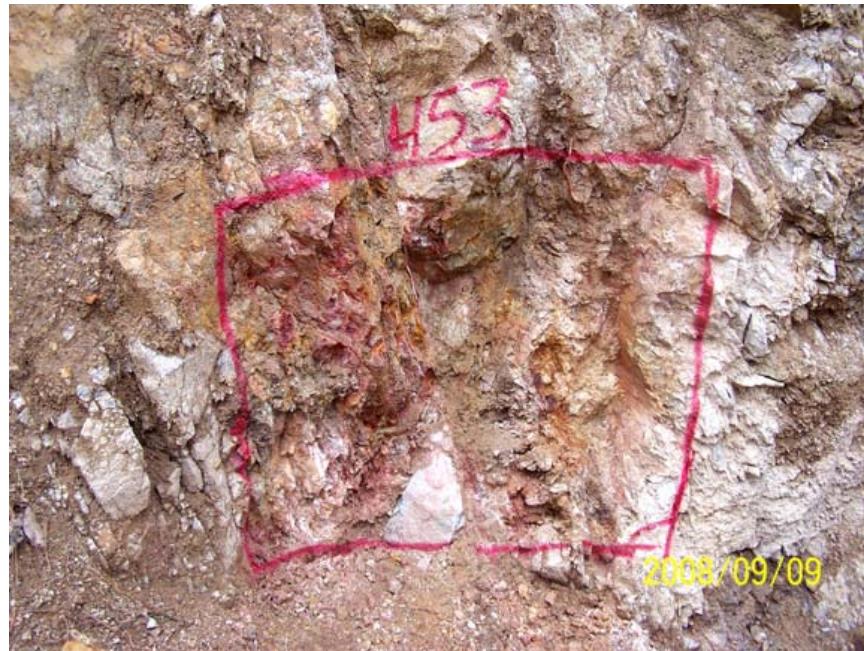
**Panel sample (387453) taken at La Vibora area on altered wall rock.
It returned 4.35 g/t gold and 119 g/t silver. The panel size is 1.50m x
1.50m**
