Figure 2A: Kulthor Decline for the Osborne Mine

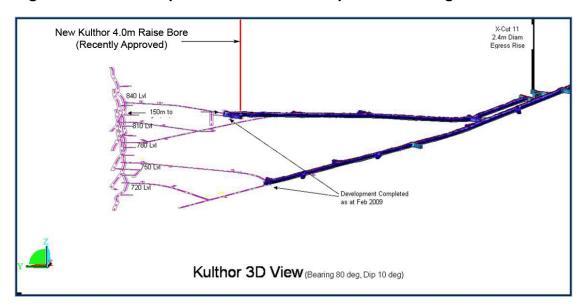
Figure 2B: Detail of planned Kulthor Development including new raise bore

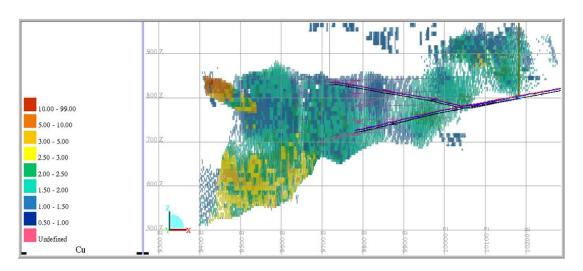
Figure 2C: Kulthor Copper Grade Blocks showing higher grade areas in south western end
