BELLHAVEN
COPPER & GOLD INC.

Figure 2
La Mina Project:
Location of La Garrucha,
La Cantera, Middle Zone
Prospects, and their
Associated Magnetic
Anomalies

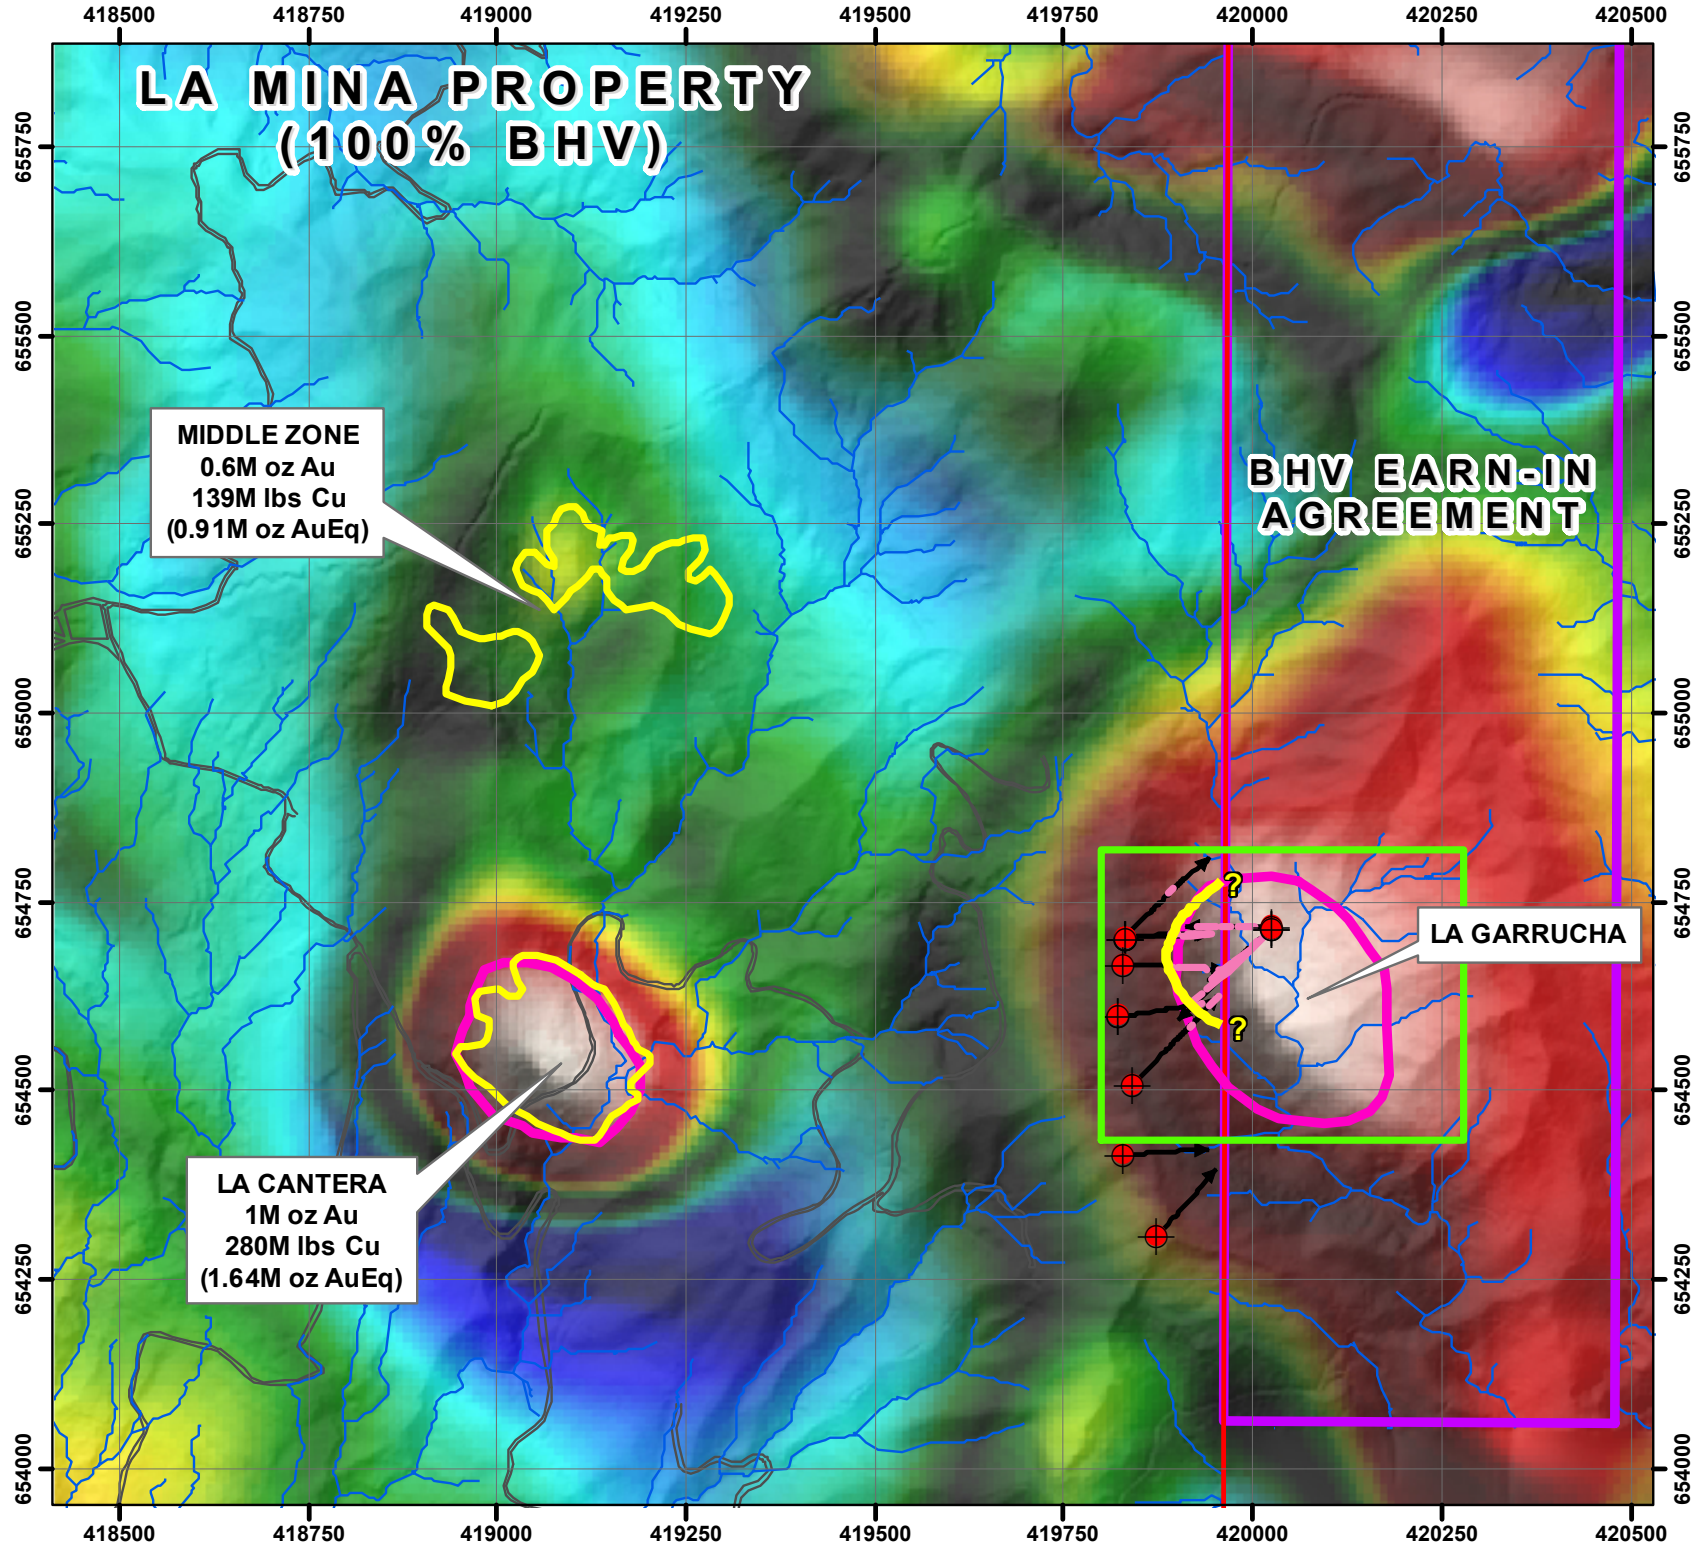
Figure 3
La Garrucha
Current Drill Hole
and Significant
Drill-Hole
Intercepts

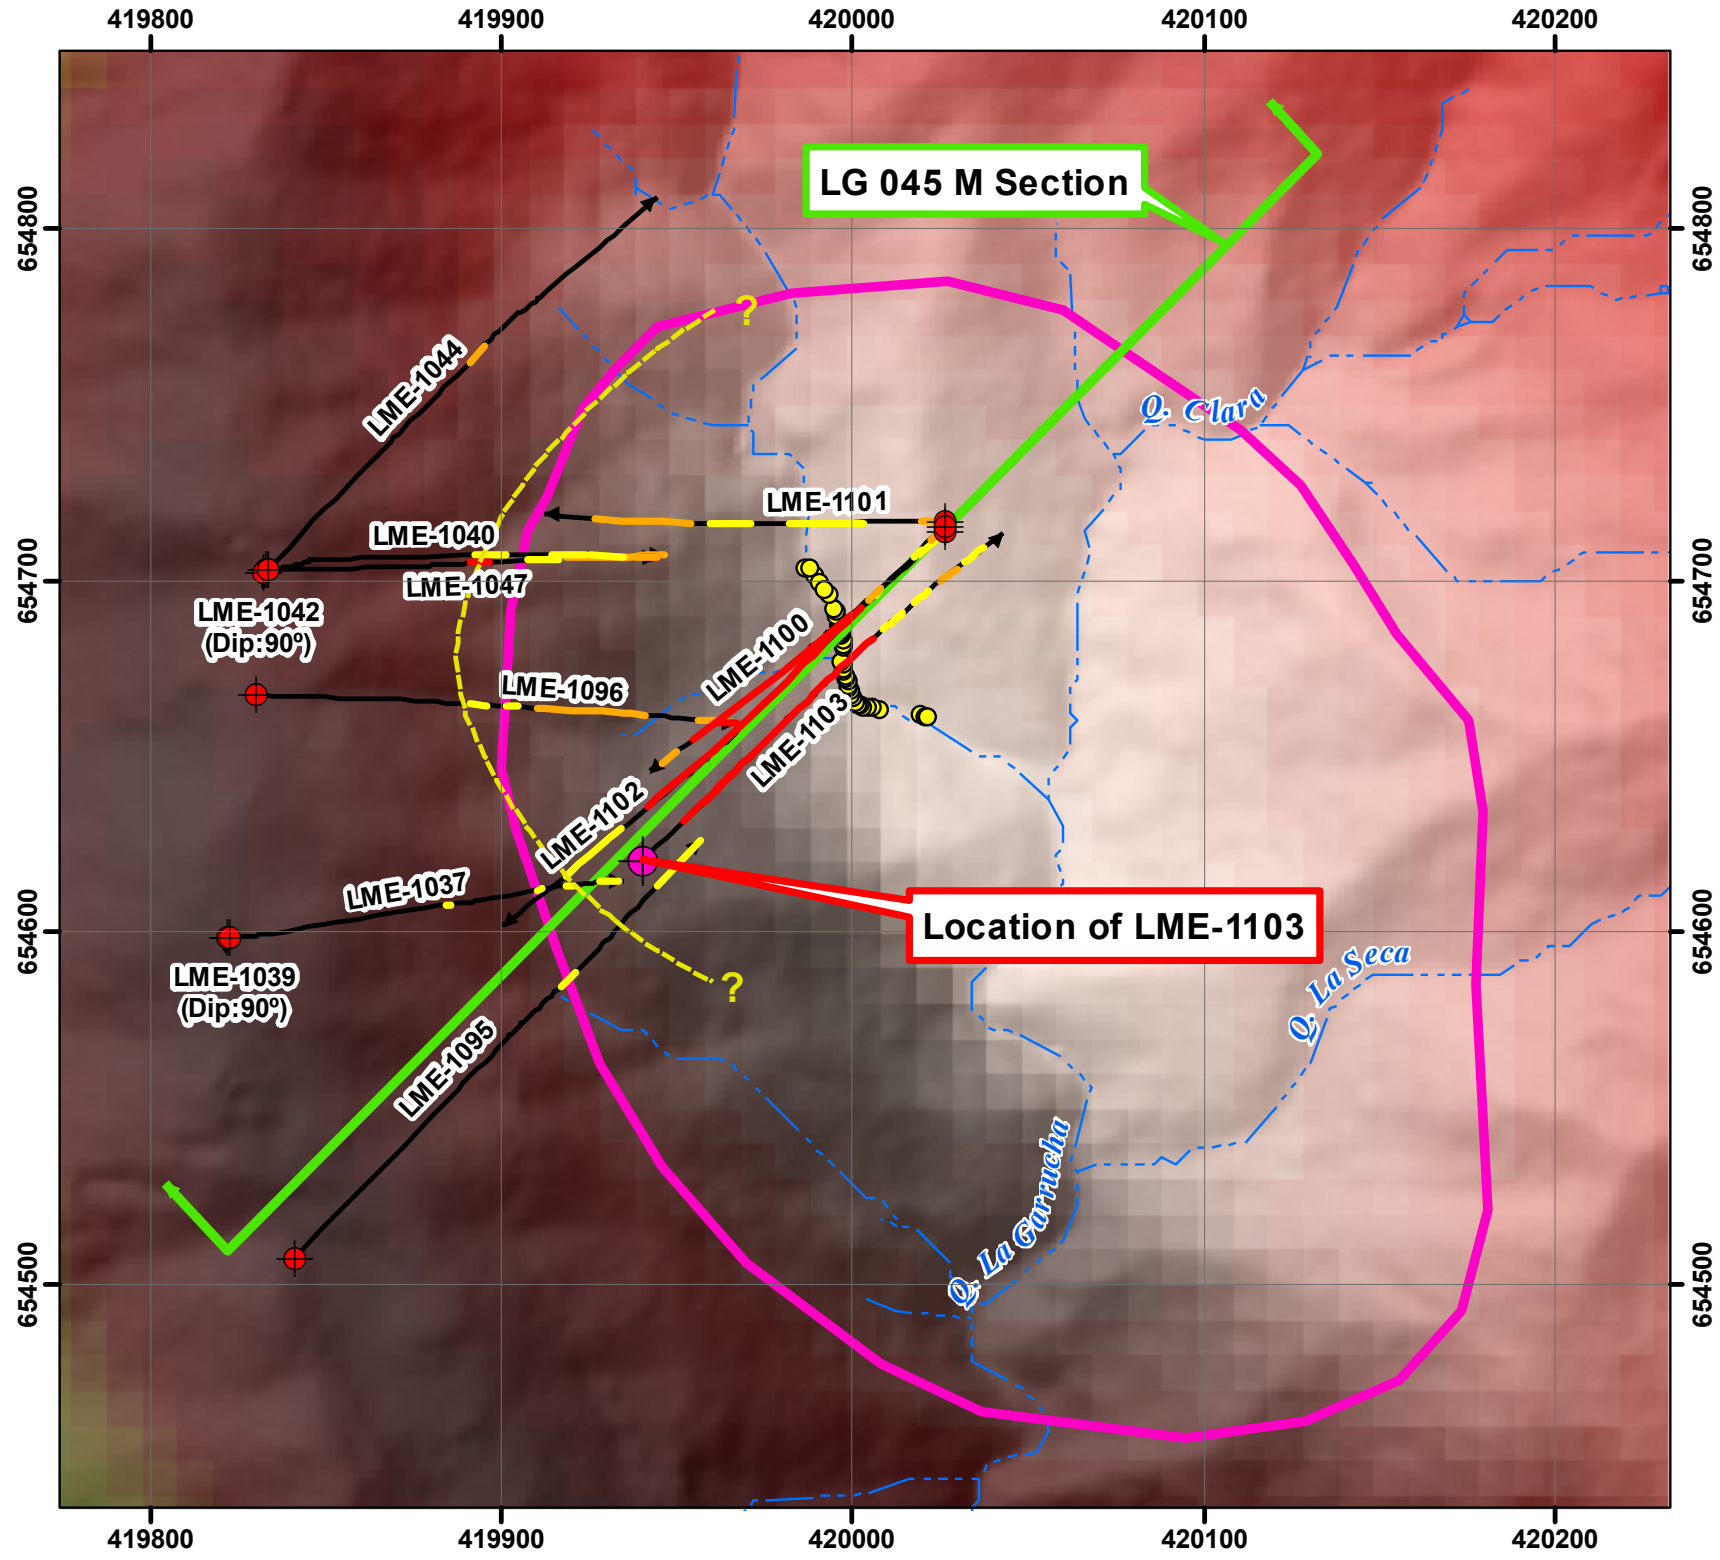
LG 045 M Section

Location of LME-1103

Figure 4. La Garrucha Section LG 045 M
Current and Previous Drill Holes
