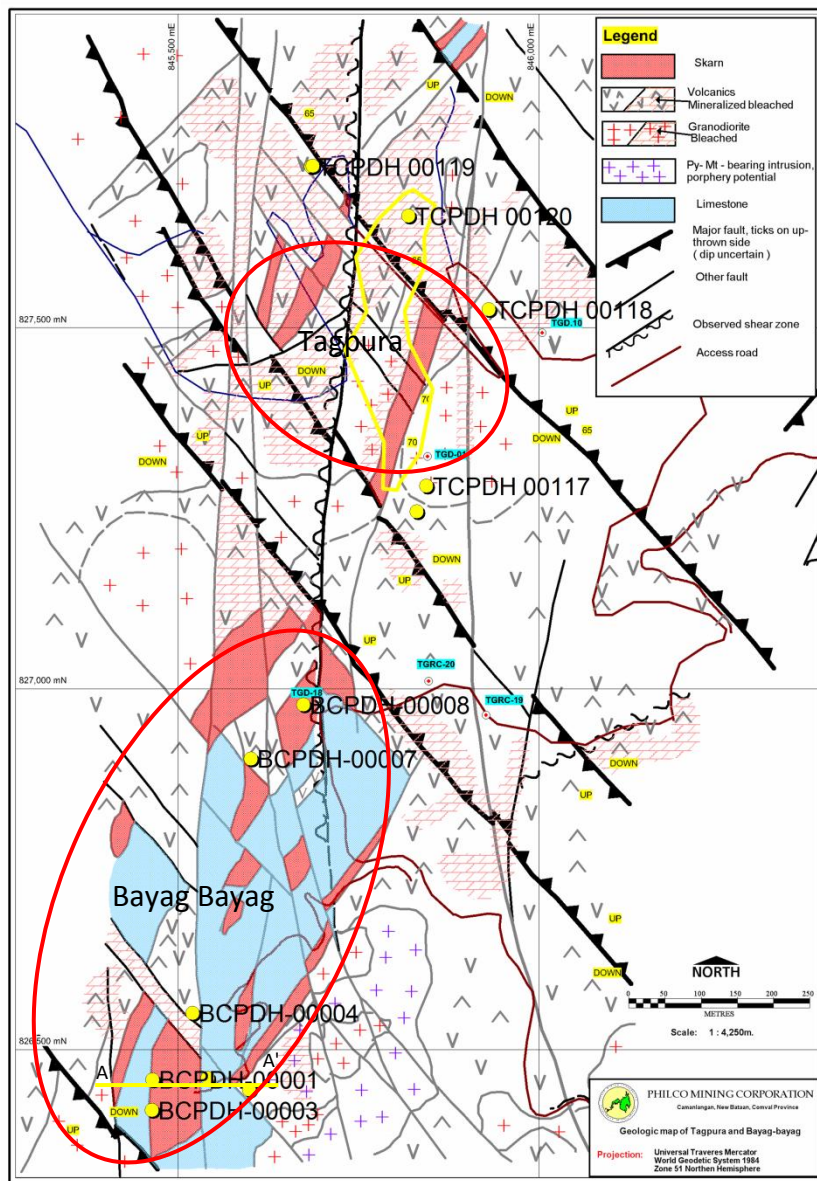
Figure 1- Geological Map of Tagpura to Bayag Bayag. Section position yellow line A-A' at Bayag Bayag shown. Bounding north west faults delineate tract of prospective geology for skarn minerlisation within downthrown fault blocks. Yellow dots denote holes drilled by Mining Group.

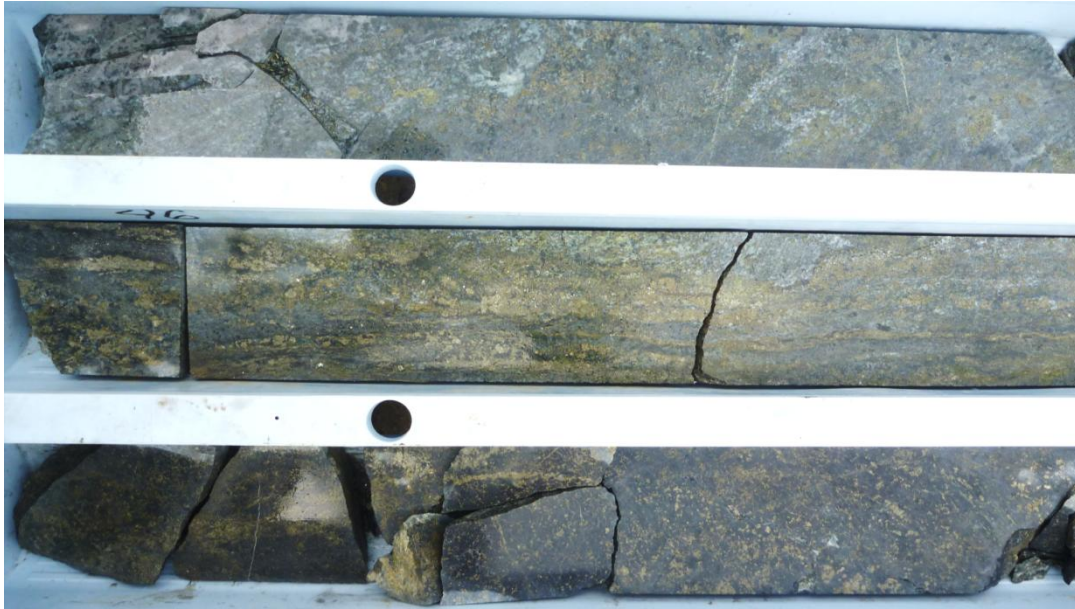
*Figure 2 - Mineralised porphyry interval in hole BCPDH00006 45.00m-47.00m downhole direction to the right, 2.00m @ 0.48% Cu, 0.19g/t Au, 1.6g/t Ag; shows steep sheeted py-cpy-mt veins (centre) with surrounding magnetite (bottom) and quartz-magnetite (top) alteration of host granodiorite.*
