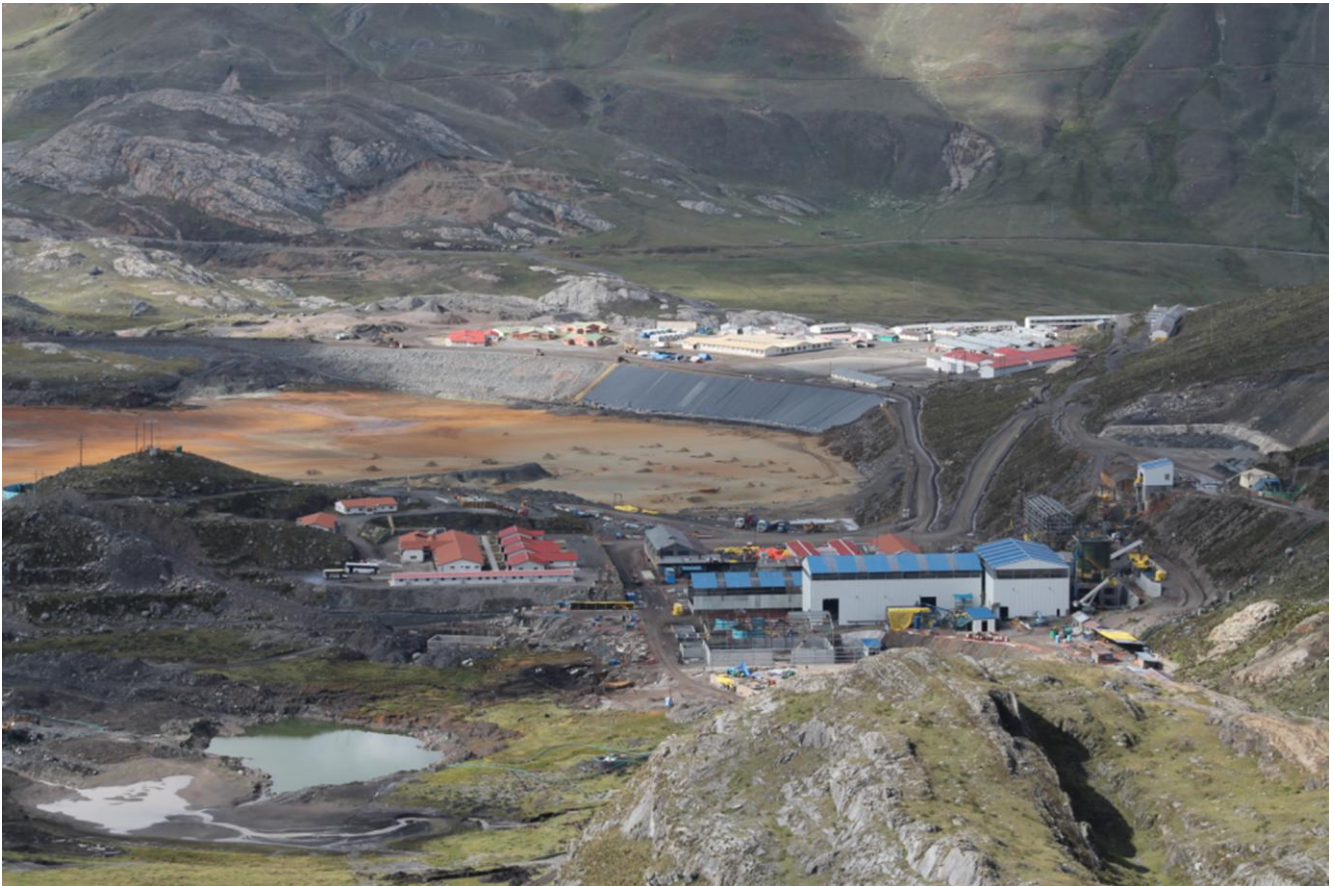
Figure 1: Santander mine site overview. Milling/processing circuit in centre-foreground, closed and fully lined tailings in mid-ground, and 500-person camp and infrastructure in background.

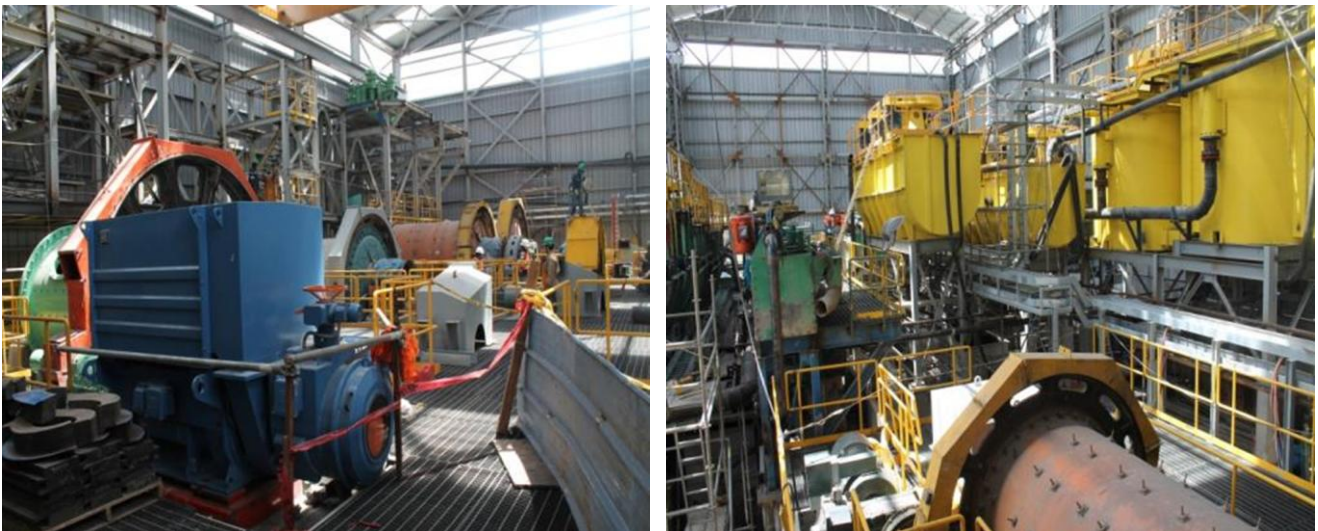
Figure 2: Santander mills and flotation circuits
